SUBJECT: "Investigation of Design, Construction, and
Erosion Control Methods for Use in Wind-
blown Silts;" KYHPR-64-14, HPR-1(1), Part II.

HIGHWAY CONSTRUCTION IN WINDBLOWN
SILTS OF WESTERN KENTUCKY

January, 1967

US 41 By-Pass, Henderson, Kentucky

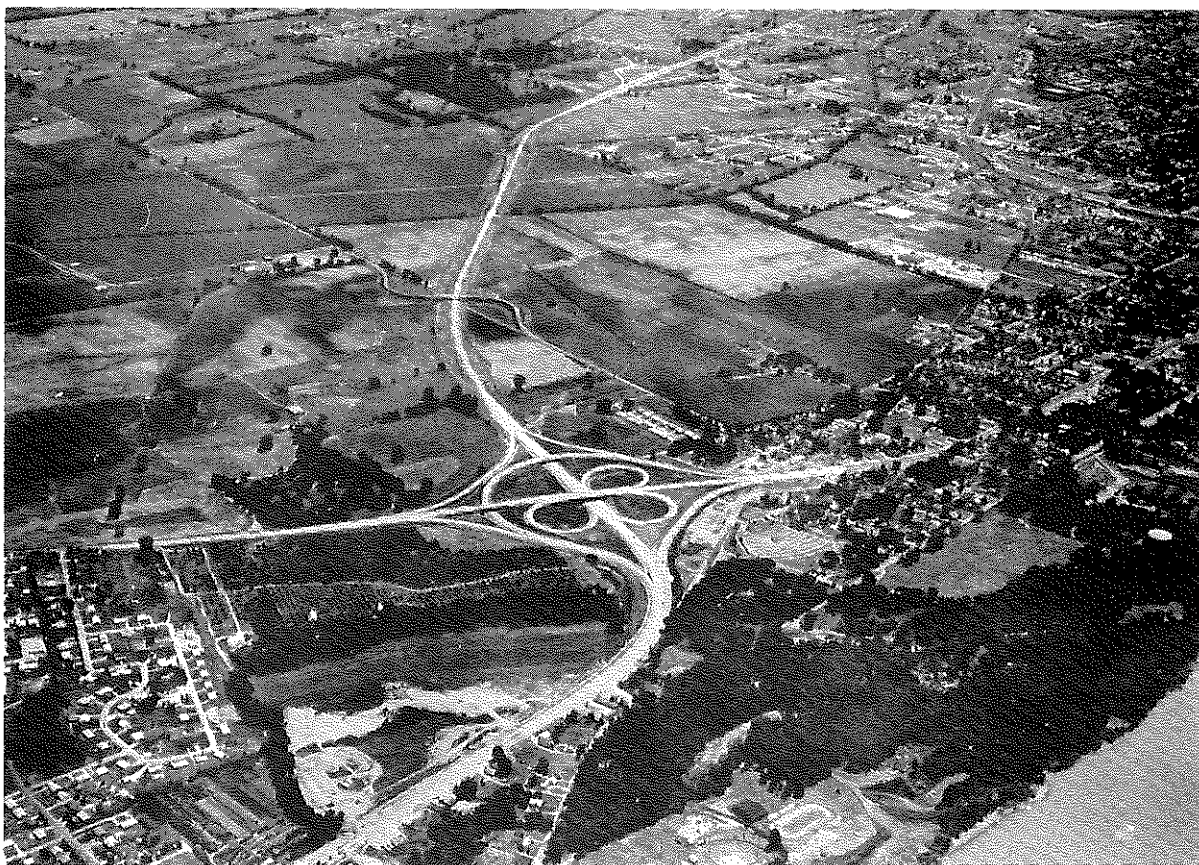
Near the northern end of the project, the location of a large interchange, there were remnants of relatively high (20 to 35 feet) loessal hills. The southern portion of the project was in similar silty material but the topography was essentially level.

Figure 6. Overall View of the US 41 By-Pass Near Henderson, Kentucky (Looking South) (1964).

The troublesome soil was first encountered on the project in August, 1960. The contractor had extreme difficulty with the soil throughout the entire project (approximately two miles long). On the northern end of the project, the difficulty arose in trying to remove the material from cuts. To the south, the difficulty occurred in borrow pits.
